✓
DOT/FAA/CT-88/27

Electro-Impulse De-Icing Research (Fatigue and Electromagnetic Interference Tests)

Institute for Aviation Research
Wichita State University

Final Report

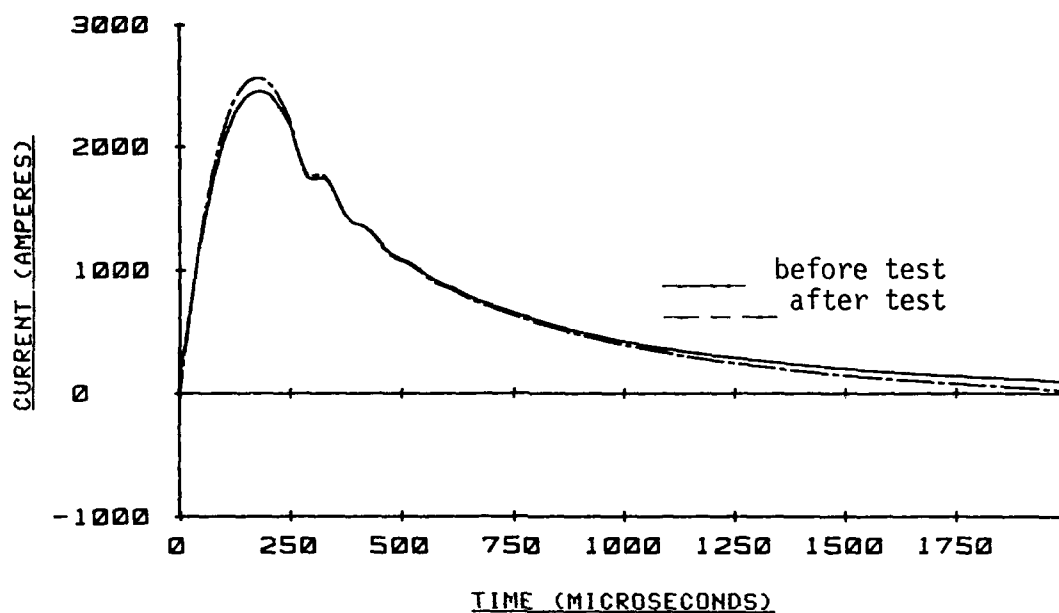
Figure 2-6
Current Traces

SKIN .025 BEFORE AND AFTER BAY 1 AND 3

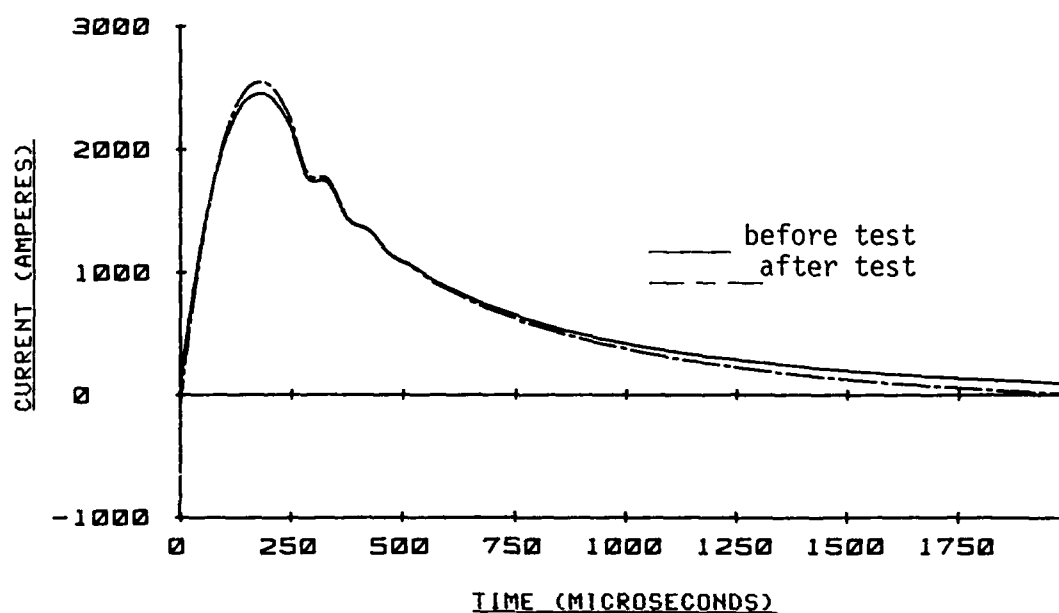
Figure 2-7
Current Traces

SKIN .025 BEFORE AND AFTER BAY 2 AND 4

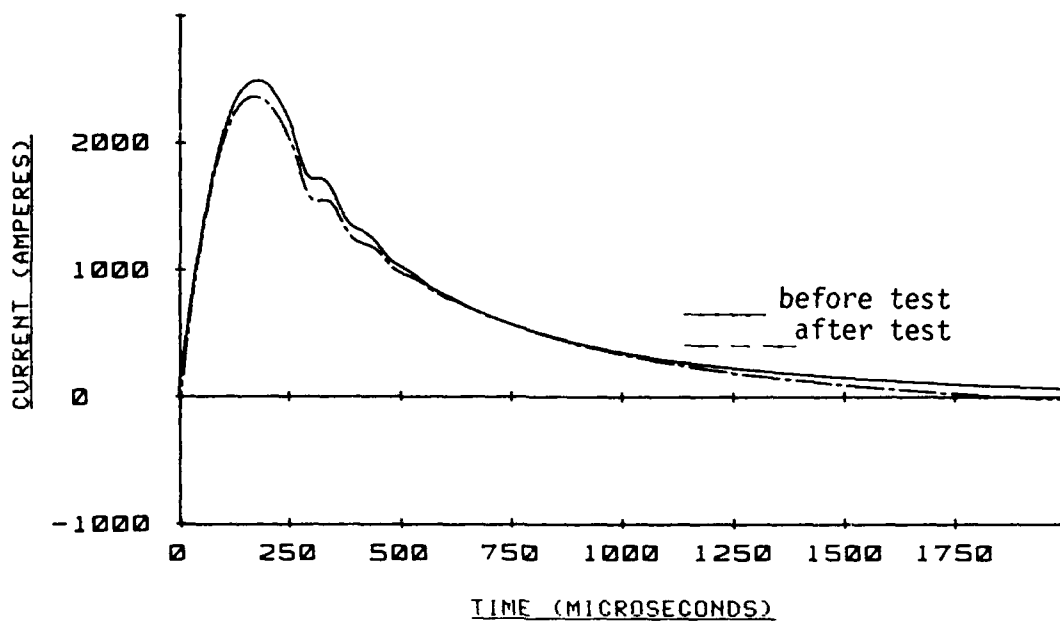
Figure 2-12
Current Traces

SKIN .040 BEFORE AND AFTER BAY 1 AND 3

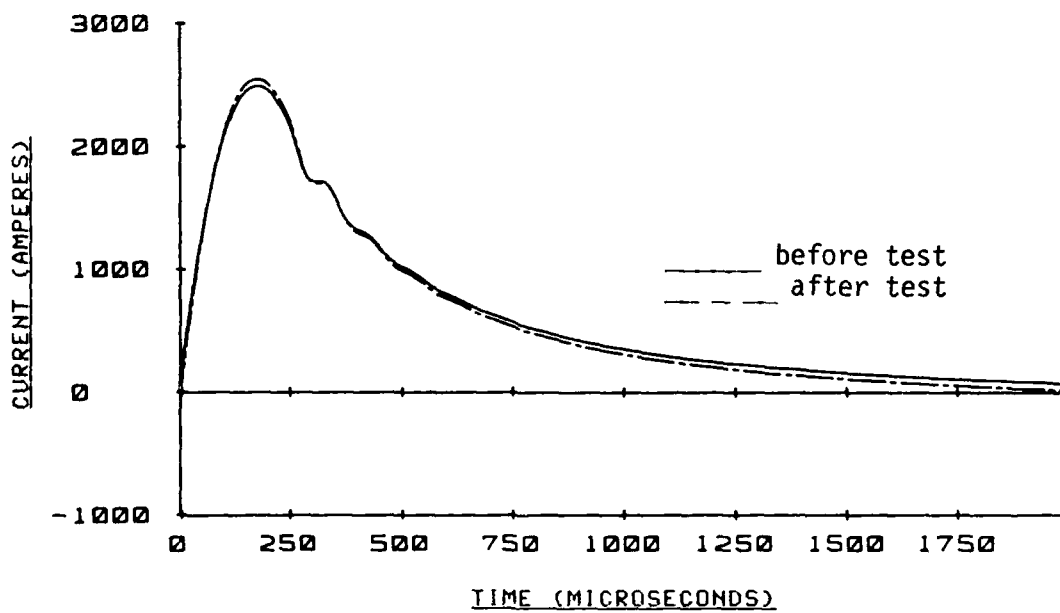
Figure 2-13
Current Traces

SKIN .040 BEFORE AND AFTER BAY 2 AND 4
